FINAL REPORT • FEBRUARY 2014

# Evaluation of Barriers to Pacific Lamprey Migration in the Eel River Basin

Wiyot Tribe  
1000 Wiyot Drive  
Loleta, CA 95551

Stillwater Sciences  
850 G Street, Suite K  
Arcata, CA 95521

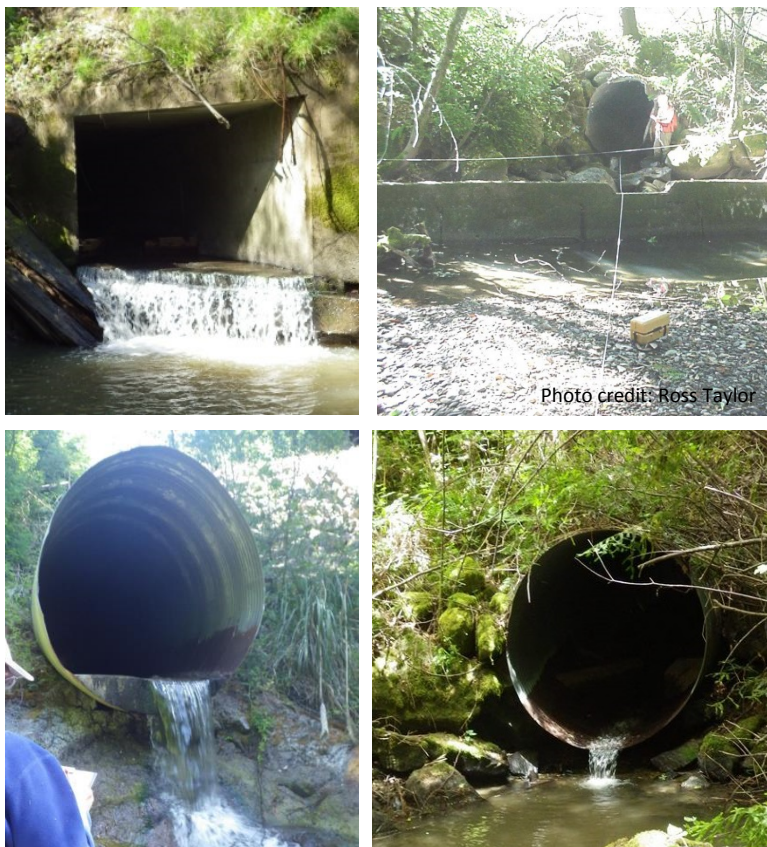
**Figure 2-3.** Examples of perched road crossings or tailwater control weirs found in the Eel River basin. Clockwise from upper left: Oil Creek (PAD ID 736789), Dinner Creek (PAD ID 723276), Stitz Creek (PAD ID 715449), Strawberry Creek (PAD ID 715429)

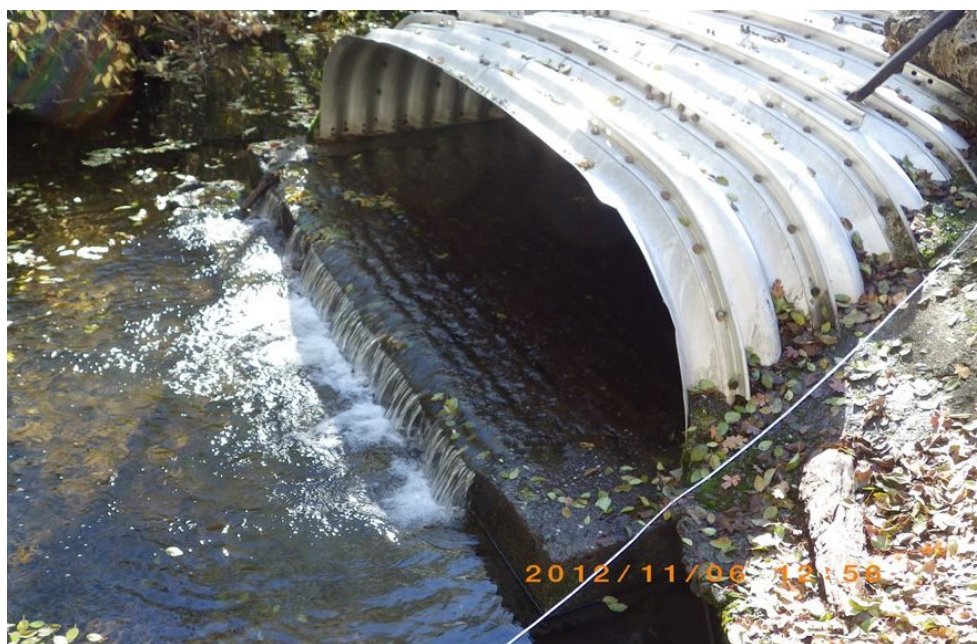
Vertical features with abrupt right angles, such as fish ladder steps, concrete culvert outlet aprons (Figure 2-4), or velocity control weirs may impede or prevent lamprey passage (Moser et al. 2002, Keefer et al. 2010). Due to uncertainties in the ability of Pacific lampreys to ascend and pass over such features, when evaluating passage for this study, we assumed that they could not pass unless the water surface met or exceeded the elevation of the top of the vertical surface (e.g., locations where a backwater effect would raise the water surface at certain flow thresholds). This was a conservative assumption that likely underestimated Pacific lamprey passage success, since lampreys can probably swim over some small steps or drops or possibly attach to and climb a horizontal surface beyond a small step. These uncertainties are discussed further in the context of fishways, culvert baffles, and weirs below.

**Figure 2-4.** Example of culvert outlet apron with a vertical step at a crossing of Butte Creek (PAD 715481).

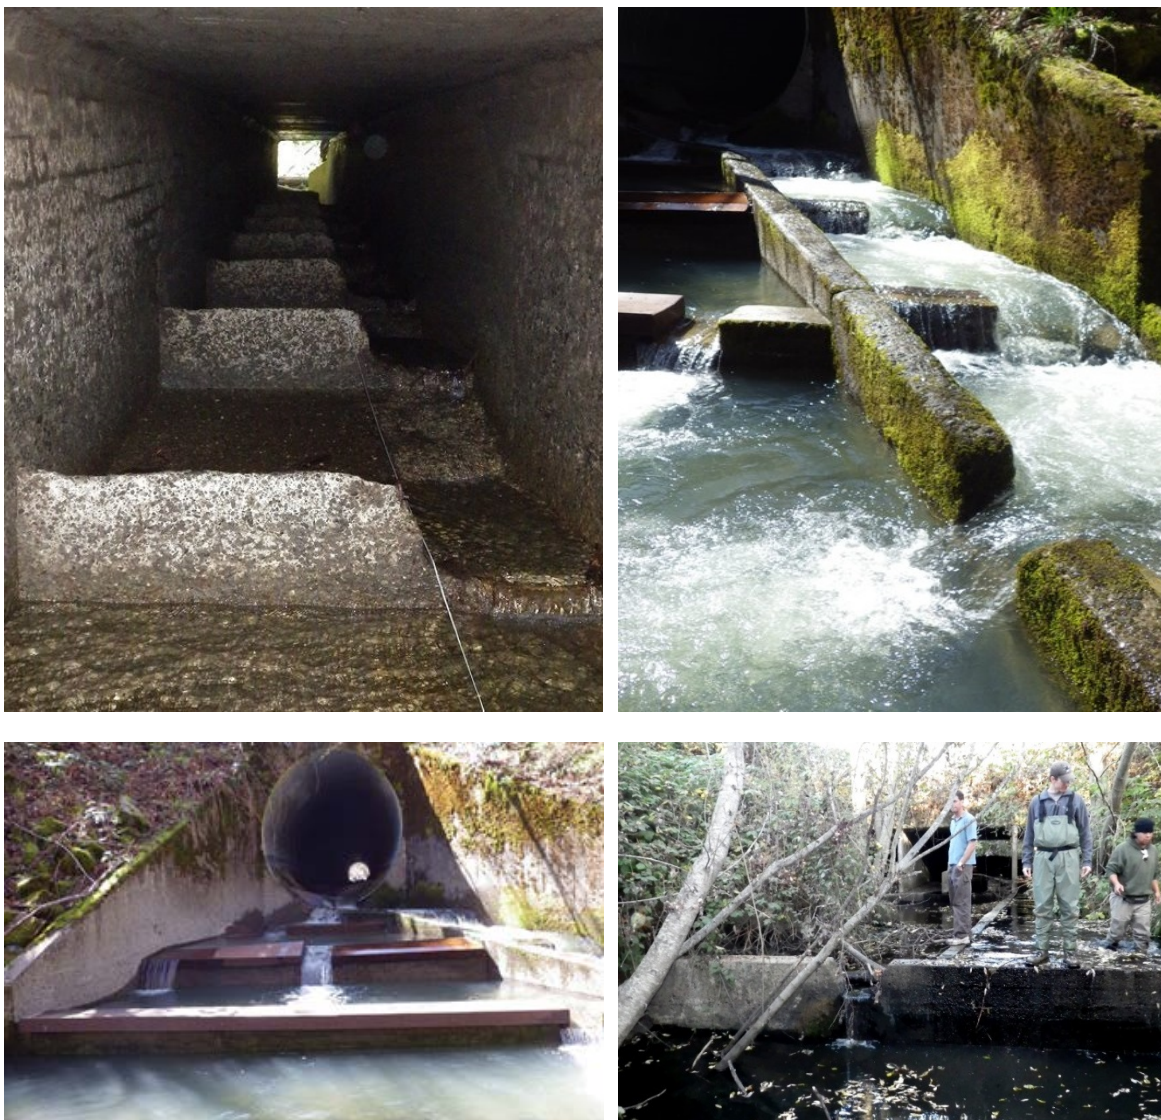
**Figure 2-5.** Examples of internal structures and modifications at road crossings in the Eel River basin. Internal baffles (top left; Fish Creek, PAD 707157), step-pool fishways at outlet (top right and bottom left; Elk Creek, PAD 707107), and tailwater control weir (bottom right; Rohner Creek at 12<sup>th</sup> St. in Fortuna, CA).

Since culvert internal structures and retrofits are typically designed specifically to improve salmonid passage and often disregard lamprey-specific requirements (e.g., CalTrans 2007), many may hinder lamprey migration, particularly if they contain sharp angles or require leaps. Laboratory and field experiments indicate that, when water velocities are high, Pacific lamprey have difficulty passing features that have squared corners such as vertical steps or vertical slot weirs in fish ladders (Moser et al. 2002, Daigle et al. 2005, Keefer et al. 2010). Such sharp angles prevent lampreys from maintaining attachment as they move around a corner (Moser et al. 2002, Moser and Mesa 2009). These same studies demonstrated that Pacific lampreys have significantly higher passage success through fishways with rounded, instead of squared, corners on bulkheads.

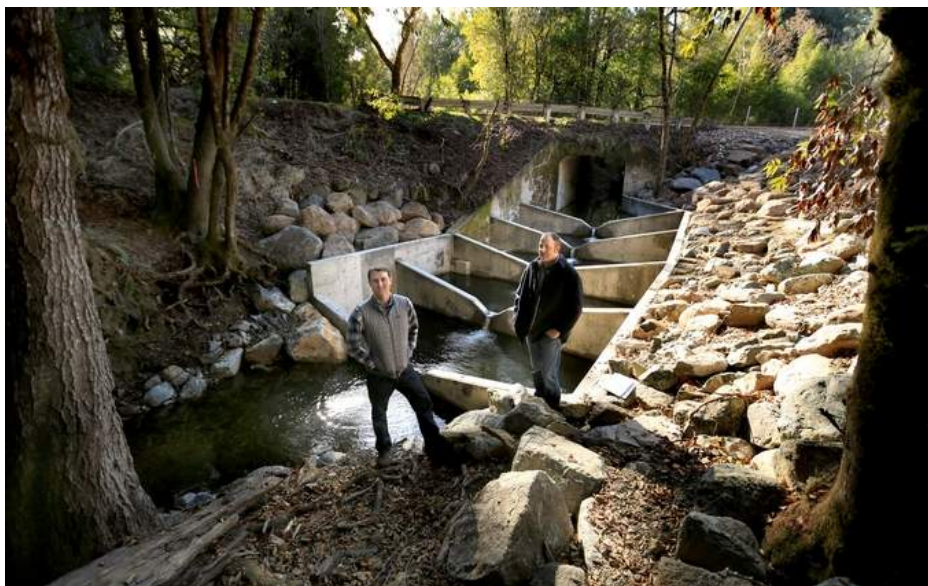
**Figure 5-1.** Example pool-weir fish ladder designed to improve salmon passage, but not well designed for Pacific lamprey passage. Source: <http://www.pressdemocrat.com/article/20140109/articles/140109595>

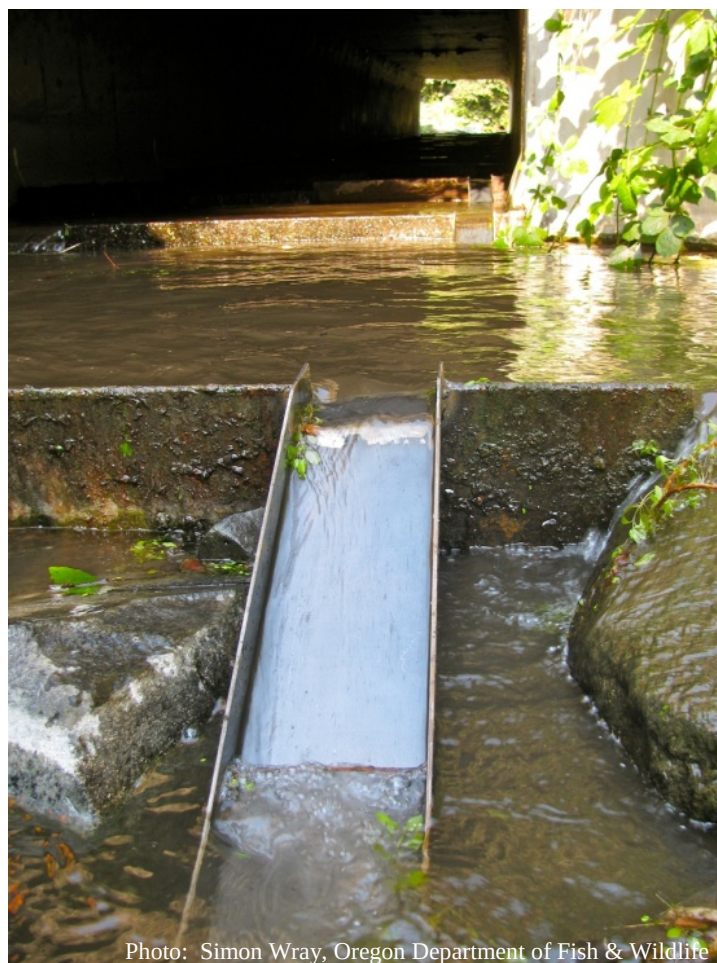
**Figure 5-2.** Example of installation of lamprey ramps to improve passage in Threemile Creek, Oregon.

- Where replacement of a perched culvert or culvert outlet apron is not possible or is cost-prohibitive, consider installing lamprey passage systems or similarly designed lamprey ramps (Moser et al. 2011). These systems take advantage of the unique attachment and climbing behavior of Pacific lampreys and have been used to improve passage efficiency through large hydropower dams (Keefer et al. 2010, Moser et al 2011). Similar technology

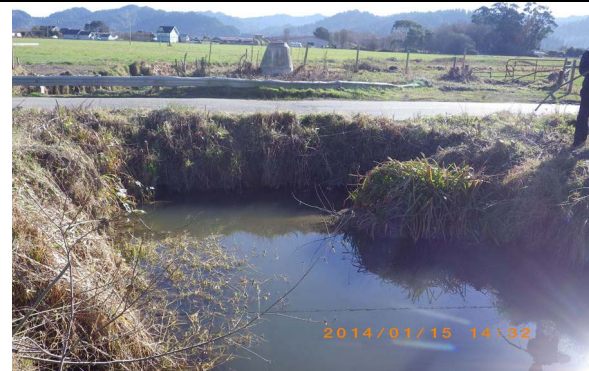
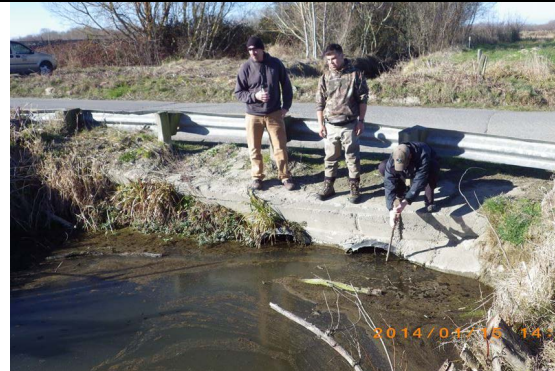
| Outlet from downstream (pipes obscured by grass) | Inlet; showing stagnant water. |

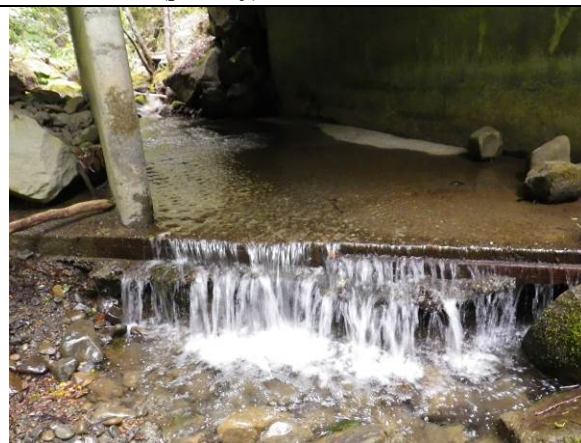
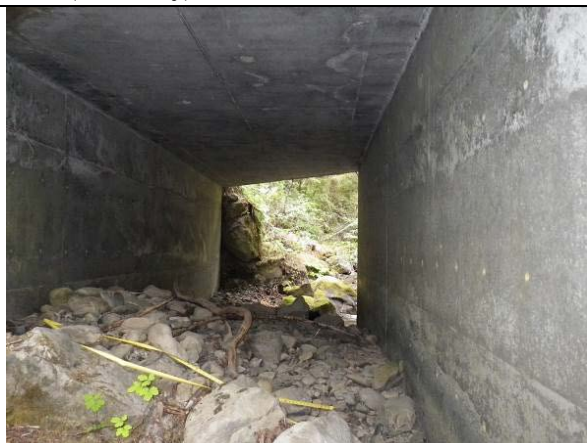
| Outlet of east (primary) culvert | West (secondary) culvert from outlet |

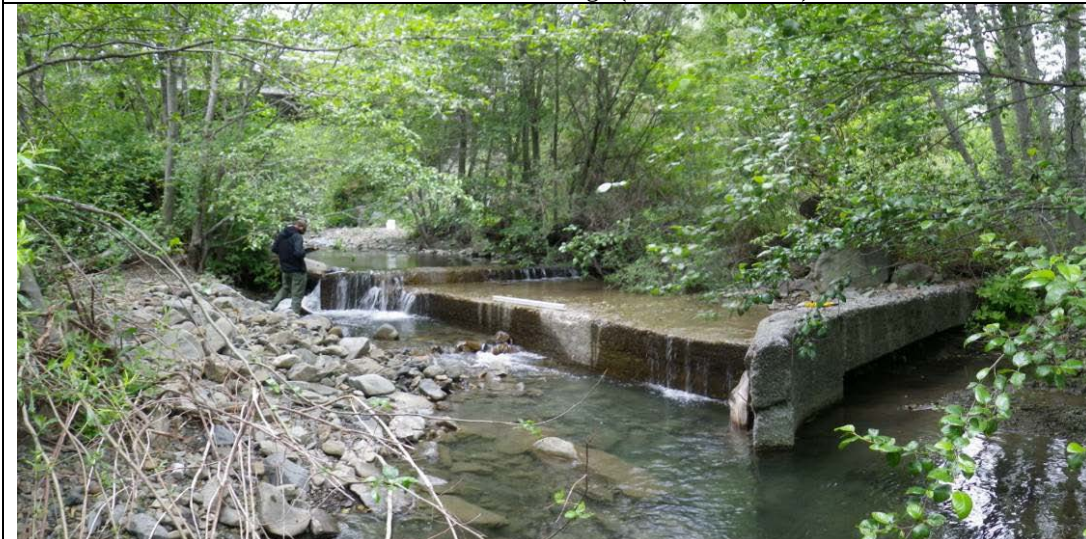
Concrete structure downstream of Mattole Road Bridge (PAD ID 736752).

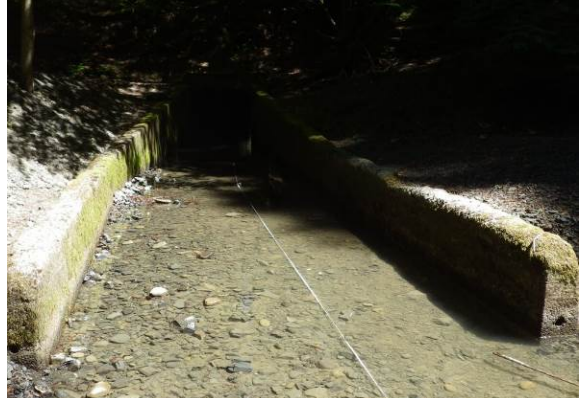
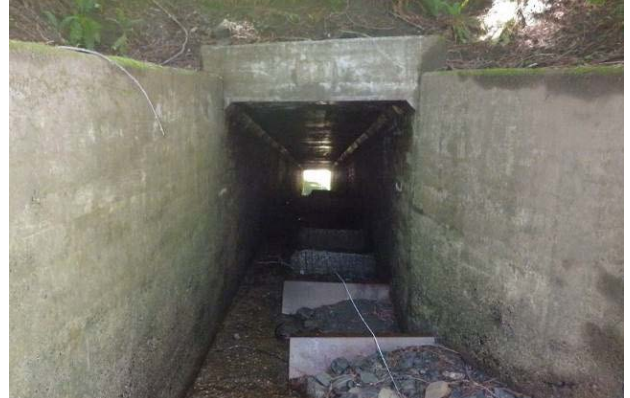
| Outlet (showing low wingwalls and buried apron) | Inlet (showing wingwalls and baffles) |

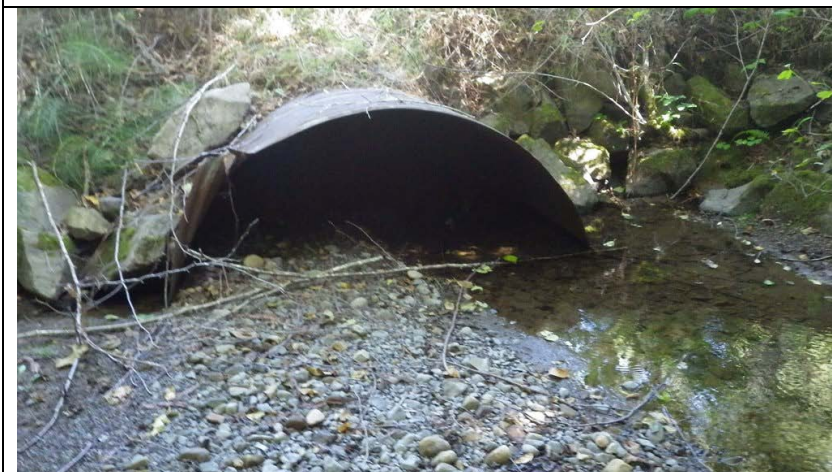
Inlet (outlet not accessible)
