FINAL REPORT • FEBRUARY 2014

# Evaluation of Barriers to Pacific Lamprey Migration in the Eel River Basin

Wiyot Tribe  
1000 Wiyot Drive  
Loleta, CA 95551

Stillwater Sciences  
850 G Street, Suite K  
Arcata, CA 95521

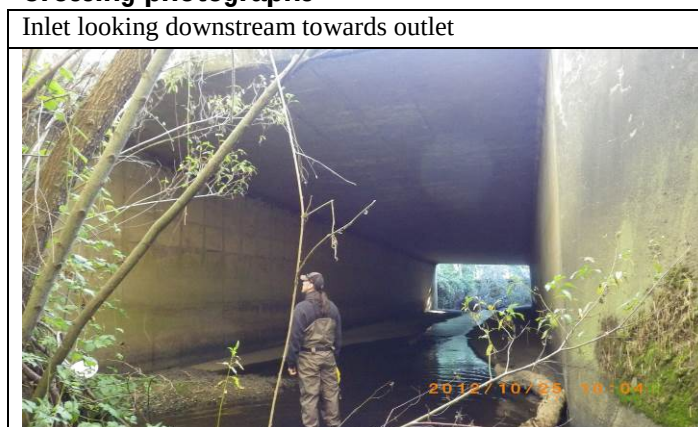
Strong's Creek flows through the city of Fortuna and is crossed by numerous other roads, several of which are not listed in the PAD. Upstream of HWY 101, we evaluated passage at PAD ID 715459. We also photo documented bridge crossings at Eel River Dr. and Riverwalk Dr. and determined they were likely not barriers at migration flows based on professional judgment. An examination of Google Earth indicates that Strong's Creek is crossed by several other public and private crossings upstream (including PAD ID 715455) that require future passage evaluation.

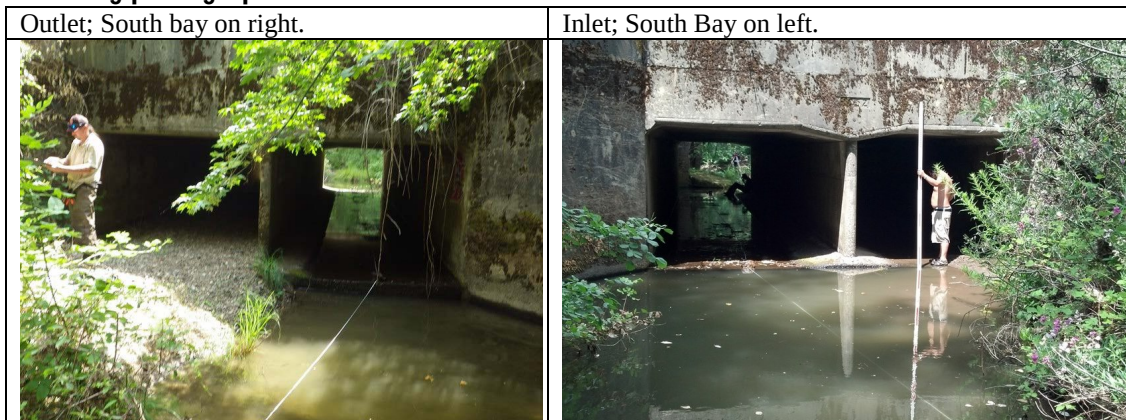
The PAD does not list additional crossings of the mainstem of Tenmile Creek. However, a cursory inspection of Google Earth imager indicates that there are numerous additional crossings both upstream and downstream of PAD ID 707096, both private and public. Most of these appear to be either bridges or low water crossings, but they should be investigated further. Marijuana cultivation in the watershed is extremely intensive (and spatially extensive) and likely exacerbates seasonal passage barriers due to reduced stream flows.

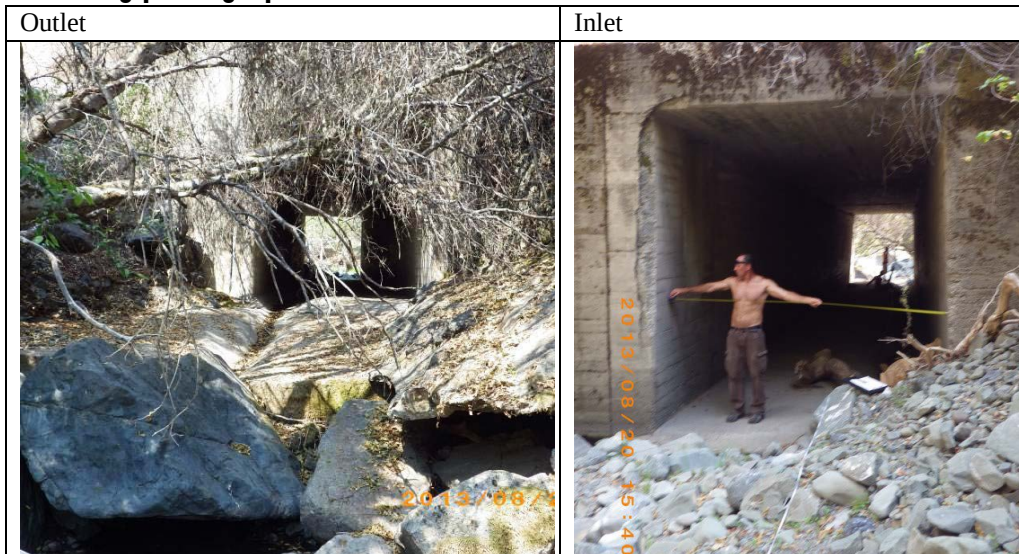
The PAD indicates that there is a significant waterfall (PAD ID 712927) that is considered the end of salmonid anadromy ~0.5 miles upstream. Field observations and GIS analysis also indicate that the reach upstream is extremely high-gradient and it is unlikely that lampreys would utilize it. Further upstream, Goforth Creek is crossed by Poonkinny Rd., a culvert that is not listed in the PAD.
